# **USS KLAKRING (FFG 42)**

# SHELL CONDITION ASSESSMENT SURVEY INTERIOR AREAS

3/26/01 - 4/6/01

**SUPSHIP PORTSMOUTH**

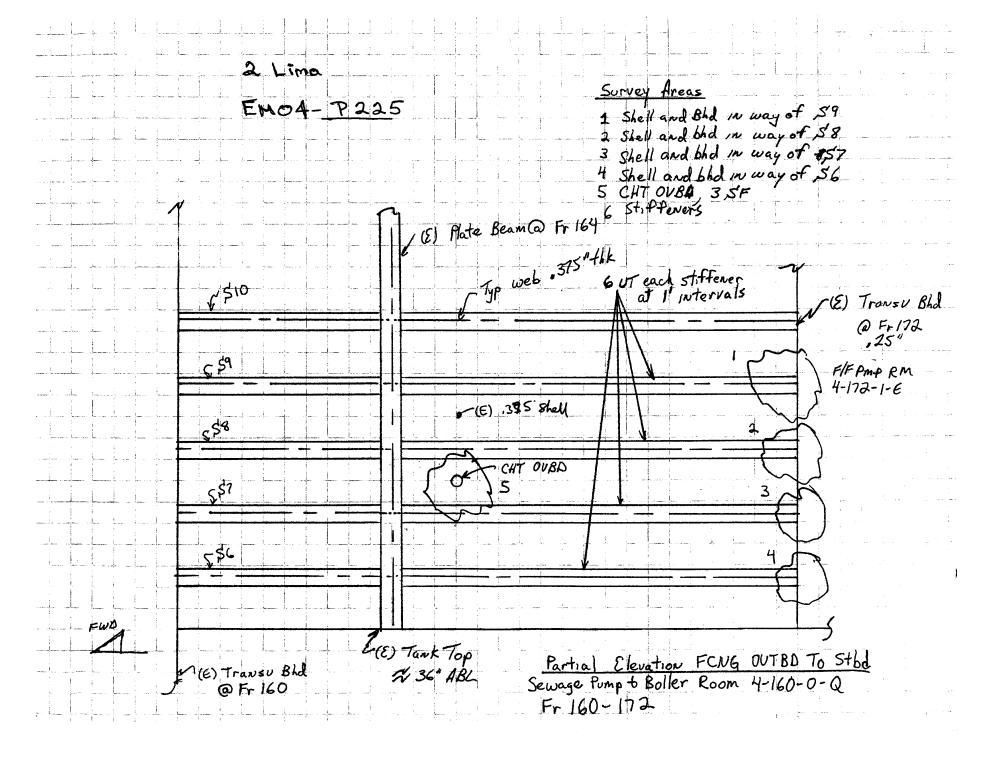
- 1. 2K's submitted:
  - a. EM04-P225 Shell and structure UT.
  - b. EM04-xxxx Stiffener replacement.
  - c. EM04-xxxx Bilge cleaning and preservation
- 2. Random UT's of corroded stiffeners and shell port and stbd, Fr 160-180, indicates corrosion is surface deterioration except as noted in the 2K's and UT readings.

DISCREPANCY DE SCRIPTIO	on: PER S	SEMATIIN	ISPECTION	OF SEW	AGE HAND	DLING & E	BOILER R	OOM (4	4-160-0	-Q),
STIFFENER S7(7"	X6 ¾"T)	FROM FR	160-172, S	8 & S9(6"	K 6 ½"T ) F	ROM FR	164- 172	AND P7	7(7"X6 <sup>:</sup>	³⁄₄"T)
FROM FR 170-175	WERE F	OUND CO	RRODED A	ND HOLE	D. UT REA	DINGS 4	/4/01 INDI	CATE S	STIFFE	NERS
ARE BELOW MINI	мим то	LERANCE	S.							
RECOMMENDED REPAIRS										
CROP OUT AND F	REPLACE	<b>APPROX</b>	IMATELY 1	17 LF OF (	7"X 6 ¾" T	) AND AF	PROX 16	LF OF	(6"X 6	½" T)
AS INDICATED AB									•	
SURFACES.										
SSPORT C221 POC	: J. BRUC	KNER (757	') <b>396-4001</b> ,	TPOC: D.	SMITH /HU	GHES, CD	I			
CSMP SUMMARY	CE HAND	LINGS DOI	LED DOOM	4.460.0.0)	OTICCUIC	c coppo	DED 7	TEST # N	MRC 110	2/1
ROOT CAUSE/AMPLIFICATI	114	LING& BOII	LER ROOM(	4-16U-U-Q)	SHFFENER	S CURRU		EP #	1.a	
SYSTEM LEVEL IMPACT										
PART NO.		NOMENO	CLATURE	QTY		NSN			CC	OST
FIRST CONTACT  DANZIN		SECOND CONT		RATE P	HONE

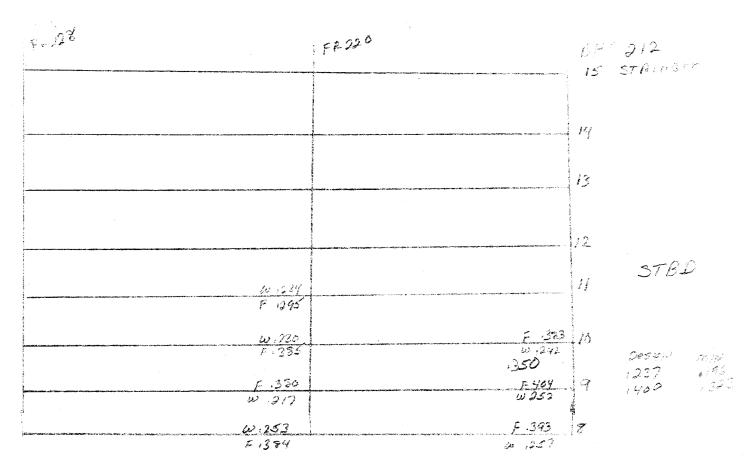
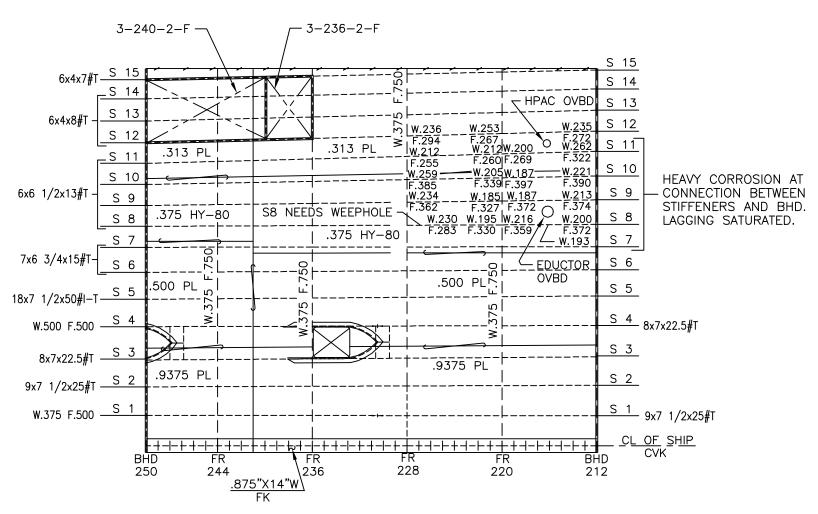
NR2 AMR 5-212-0-E

5. COMBUSTIBLE MATERIAL			6. N	NONE OF TH	IE ABOVE,	, DESCRIB	E IN REMA	RKS/DESCR	IPTION SECTIO	N .		4	
DISCREPANCY DE SCRIPTI	on: PER SEI	MAT I INSPE	ECTION	I OF A	MR 2	2 (5-21	12-0-E	), THE	SHELL	LAGGIN	G		
STBDSIDE, FR 21	2-226, FRO	M THE BOT	TOM E	DGE C	F TH	IE LA	GGIN	G TO	1' ABOV	E THE U	/L GRA	TING &	
PORTSIDE, FR 212	2-226, FRO	M THE BOT	ГОМ ЕС	OGE O	F TH	E LA	GGIN	3 TO 1	' ABOV	E THE U/	L GRA1	TING	
WAS FOUND SAT	URATED.												
RECOMMENDED REPAIRS													
REMOVE APPRO	V 225 SE O	E CATUDAT	ED CU		ICI II	ATIO	N DE	MOVE	CORR	OCION EV	/DOSEI	) BV	
REIVIOVE APPRO	A. 223 SF U	r SATUKAI	ED SH	ELL II	NOUL	AIIO	IN. KE	IVIOVE	CORR	JSIUN E	KPUSEL	ום כ	
INSULATION REM	OVALS. PR	IME AND PI	RESER	VE SH	IELL .	AND	STRU	CTUR	E AND I	NSTALL	NEW		
INSULATION. PAIR	NT NEW INS	SULATION T	О МАТ	CH SU	JRRC	DUND	ING A	REAS	) <u>.</u>				
SSPORT C221 POC	: J. BRUCK	NER (757) 396	6-4001,	TPOC	: D. S	MITH	/HUG	HES, C	DI

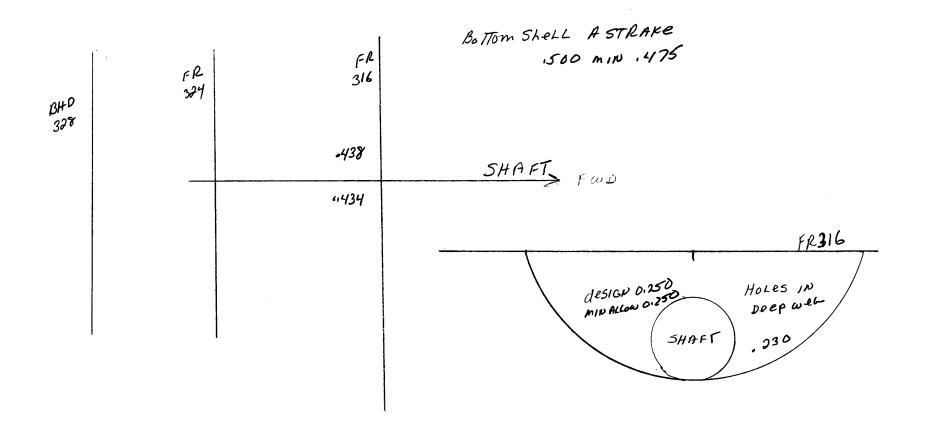
- 1. No 2K's submitted
- 2. Corrosion noted in bilge areas is covered under SEMAT Structural assessment JSN's. Ships force is spot cleaning and painting bilge areas also.
- 3. Random UT's of corroded stiffeners and shell around the stern tube, Fr 326 L/L indicate corrosion is surface deterioration.

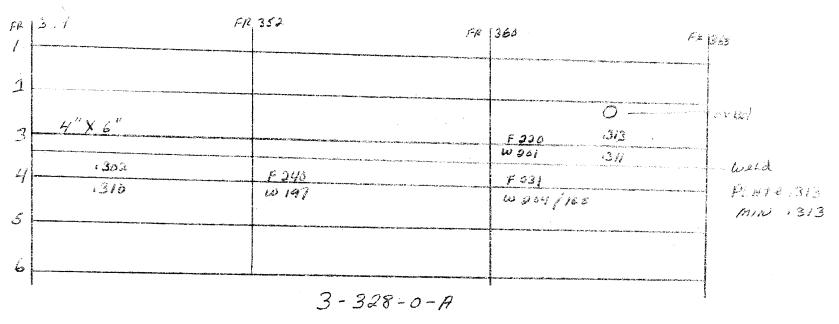
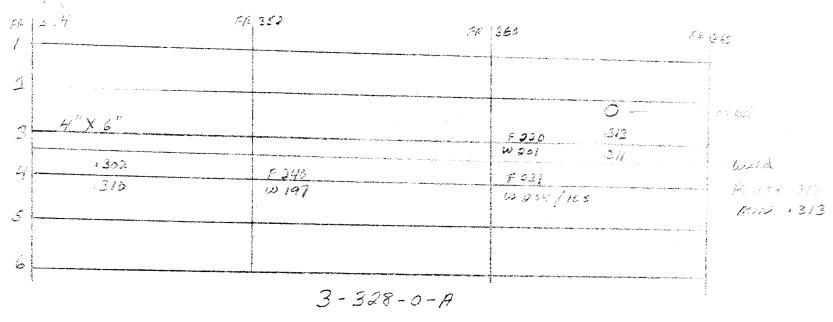
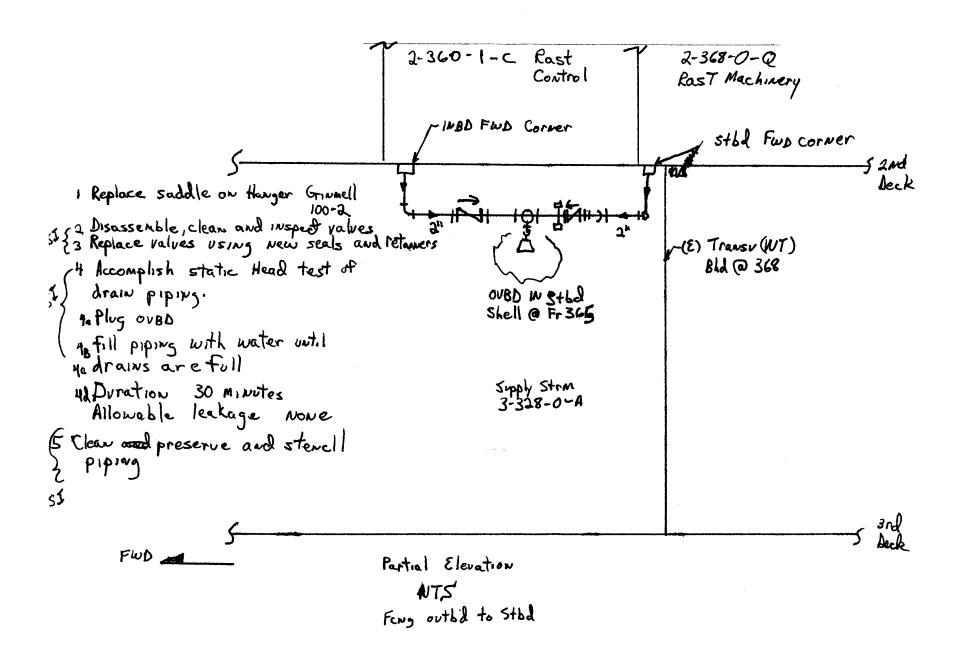
SUPPLY ISSUE STORE ROOM

SPACE	LAGGING INSTALLED	INSPECTED DURING	HISTORICAL			SAT/UNSA
SPACE NUMBER	ASSESSABLE	ON BHD	SEMAT I	HOT SPOT	COMMENTS	2K	Т
		LAGGING WAS OPENED			SEE SPECIFICS SECTION. GRAY WATER DRAIN LINE LEAK DISCOVERED BY MOISTURE CHECK. INVESTIGATION REVEALED SURFACE CORROSION ON THE SHELL AND STIFFENERS BEHIND THE LAGGING IN WAY OF THE LEAK. UT	2K SUB. FOR CORR. AND LEAK	
3-180-5-A	Υ	TO EXPOSE CORROSION	N		ACCOMPLISHED 4/4. SAT.	REPAIR	UNSAT
3-196-2-A	Y	ANTI-SWEAT COATING	N		SPACE WAS EMPTY. 100% ASSESSABLE	N	SAT
		LACCING WAS OPENED			SEE SPECIFICS SECTION. DECK DRAIN LINE LEAK DISCOVERED BY MOISTURE CHECK. INVESTIGATION REVEALED SURFACE CORROSION ON THE SHELL AND STIFFENERS BEHIND THE LAGGING FROM FR 330 TO 367. UT ACCOMPLISHED 4/4. SAT.SHIPYARD TO	2K SUB. FOR CORR. AND	
2 222 2 4	V	LAGGING WAS OPENED	NI .		REMOVE LAGGING AND	LEAK	LINGAT
3-328-0-A	Υ	TO EXPOSE CORROSION	N		CLEAN AND PRESERVE.	REPAIR	UNSAT

DISCREPANCY DE SCRIPTI	ON: PER S	SEMAT I	INSP	ECTIO	N OF	SUPPL	Y S	TRM (3	3-328	-0-A	), THE	DEC	K DR	RAIN	PIPING
FROM RAST CON	TROL RO	OOM (2-3	60-1-	C) AND	RAS	ST MAC	HINE	ERY R	OON	l (2-3	868-0-	Q) IS	LEA	KING	AT FR
365 AND DAMAGI	NG THE	SHELL L	.AGG	ING AN	ID C	ORRODI	NG	THE S	HEL	L AN	ID ST	RUCT	URE		
RECOMMENDED REPAIRS															
REMOVE THE PIP	PE HANG	ER SAD	DLE A	AND TH	IE (2	) 2" IPS	CHE	ECK V	ALVI	ES A	T FR	366 IN	THE	OVE	ID.
INSTALL A NEW H	IANGER.	OVERH	AUL	CHECK	VAI	LVES AN	ID R	EINST	ΓALL	WIT	H NE	W SE	ALS A	AND	
RETAINERS. PLU	G THE O	VBD AN	D TE	ST REP	AIR	ED PIPIN	IG. /	ALLOV	NAB	LE L	EAK	AGE:	NON	E	
SSPORT C221 POC	: J. BRUC	CKNER (7	57) 39	96-4001,	TPO	DC: D. SI	MITH	I /HUGI	HES,	CDI					
CSMP SUMMARY SUPPI	Y STRM (	(3-328-0-4	A) DF(	CK DRAI	N PII	PING I FA	KIN	G				TES	T # M	RC 11	02/1
ROOT CAUSE/AMPLIFICATI	114	(0 020 0 7	<u>,, , , , , , , , , , , , , , , , , , ,</u>	<u> </u>				<u> </u>				STEP	# 1	1.a
